**Flood Control Project Maintenance
Levee Inspections**

Maintenance Issue Types Only, Levee Inspection Report By Mile - Spring 2016

San Joaquin County Flood Control and Water Conservation District

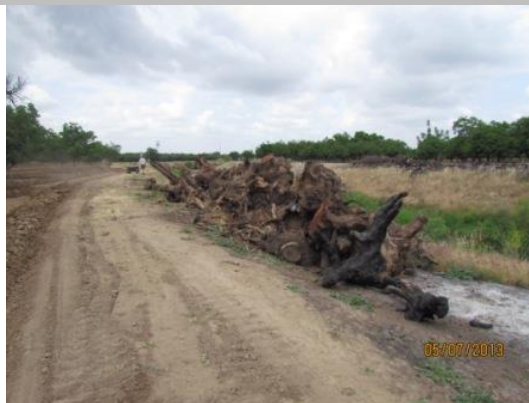
Photo 1 of 2 : SP_2016_NA0017_160_90_20160219_00080.jpg

LM Start	10.75	Rating **	M	Issue No.	90
LM End	10.75	Issue Type +	Ma	Location *	WS
Category	Earthen Levee			GPS Latitude/Longitude	
				Start	End
Item	Encroachments			37.962472 °	37.962472 °
				-121.158112 °	-121.158112 °
DWR ID	DWR_NA0017_16_s_2012_90				
Comment Code					
PR : Prunings					
Inspector Comment

Prunings were found on the waterside shoulder of the levee looking downstream.

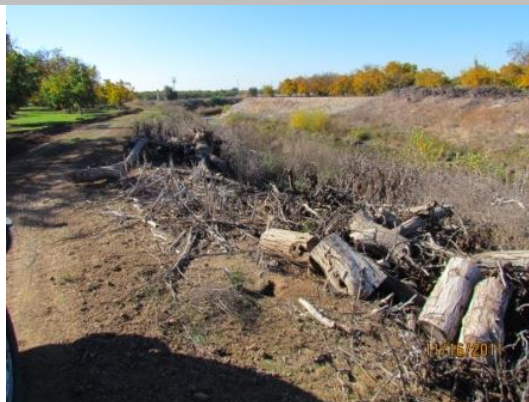
Photo 2 of 2 : SP_2016_NA0017_160_90_20160219_00081.jpg

Prunings were found on the waterside of the levee looking downstream.

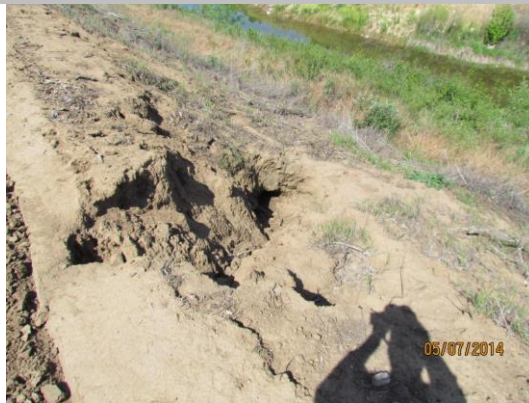
Photo 1 of 2 : SP_2016_NA0017_160_139_20160219_00108.jpg

LM Start	10.79	Rating **	M	Issue No.	139
LM End	10.79	Issue Type +	Ma	Location *	WS
Category	Earthen Levee			GPS Latitude/Longitude	
				Start	End
Item	Erosion / Bank Caving			37.962182 °	37.962182 °
				-121.158684 °	-121.158684 °
DWR ID	DWR_NA0017_16_s_2013_139				
Comment Code					
E2 : Schedule repair of erosion site prior to the next inspection.					
Inspector Comment

Updated picture of the erosion on the waterside shoulder of the levee looking downstream.

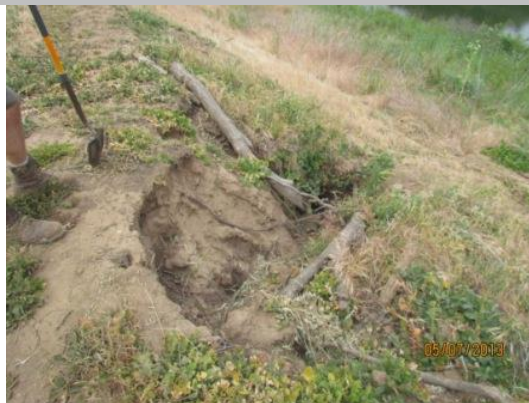
Photo 2 of 2 : SP_2016_NA0017_160_139_20160219_00109.jpg

Erosion was found on the waterside of the levee looking downstream.

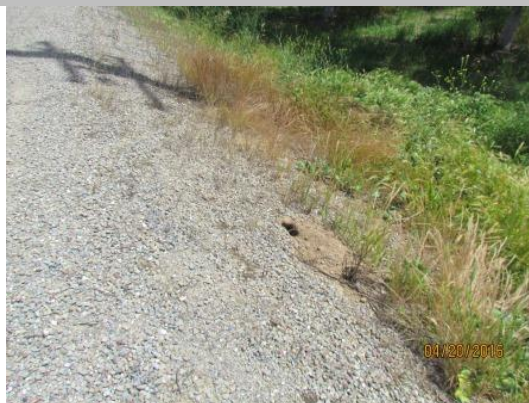
Photo 1 of 1 : SP_2016_NA0017_160_126_20160427_00376.jpg

LM Start	12.32	Rating **	M	Issue No.	126
LM End	12.32	Issue Type +	Ma	Location *	LS
Category	Earthen Levee			GPS Latitude/Longitude	
				Start	End
Item	Animal Control			37.960427 °	37.960427 °
				-121.185560 °	-121.185560 °
DWR ID	DWR_NA0017_16_s _ 2016_126				
Comment Code					
A3 : No rodents visible, but rodent burrows visible; need to backfill and compact or grout burrows.					
Inspector Comment

View of a rodent hole on the landside of the levee.

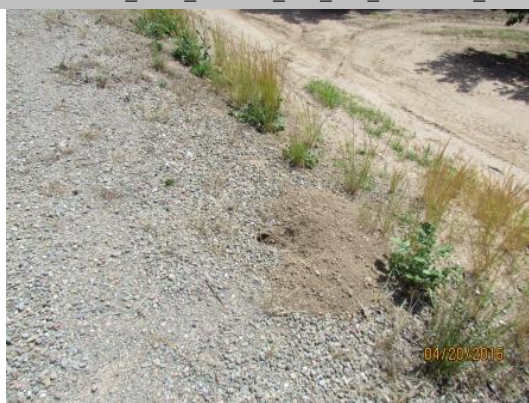
Photo 1 of 1 : SP_2016_NA0017_160_244_20160427_00377.jpg

LM Start	12.87	Rating **	M	Issue No.	244	
LM End	12.87	Issue Type +	Ma	Location *	LS	
Category	Earthen Levee			GPS Latitude/Longitude		
				Start	End	
Item	Animal Control			37.959694 °	37.959694 °	
				-121.195381 °	-121.195381 °	
DWR ID	DWR_NA0017_16_s _ 2016_244					
Comment Code						
A3 : No rodents visible, but rodent burrows visible; need to backfill and compact or grout burrows.						
Inspector Comment

View of rodent holes on the landside of the levee.

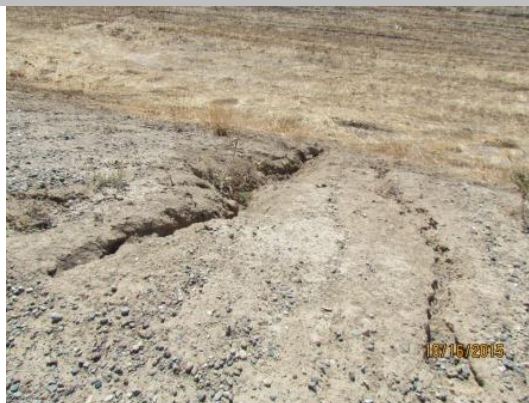
Photo 1 of 1 : SP_2016_NA0017_160_249_20160219_00147.jpg

LM Start	14.25	Rating **	M	Issue No.	249
LM End	14.25	Issue Type +	Ma	Location *	LS
Category	Earthen Levee			GPS Latitude/Longitude	
				Start	End
Item	Erosion / Bank Caving			37.967046 °	37.967046 °
				-121.217319 °	-121.217319 °
DWR ID	DWR_NA0017_16_f_2015_249				
Comment Code					
E2 : Schedule repair of erosion site prior to the next inspection.					
Inspector Comment					
Runoff

View of the erosion caused by surface runoff on the landside of the

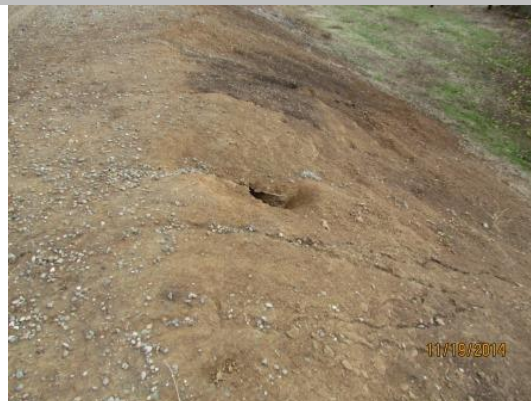
Photo 1 of 1 : SP_2016_NA0017_160_260_20160219_00149.jpg

LM Start	14.48	Rating **	M	Issue No.	260
LM End	14.48	Issue Type +	Ma	Location *	LS
Category	Earthen Levee			GPS Latitude/Longitude	
				Start	End
Item	Animal Control			37.968800 °	37.968800 °
				-121.220755 °	-121.220755 °
DWR ID	DWR_NA0017_16_f_2014_260				
Comment Code					
A3 : No rodents visible, but rodent burrows visible; need to backfill and compact or grout burrows.					
Inspector Comment

Rodent holes were found on the landside slope of the levee looking upstream.

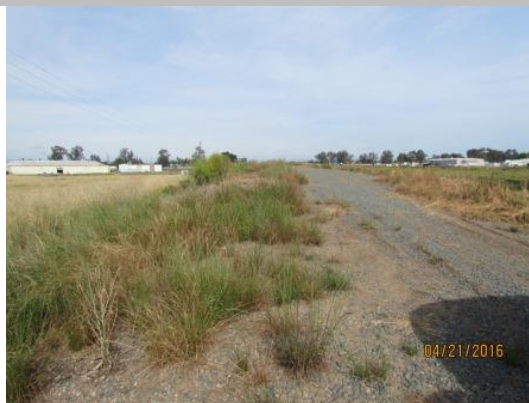
Photo 1 of 1 : SP_2016_NA0017_160_290_20160427_00378.jpg

LM Start	15.98	Rating **	M	Issue No.	290
LM End	19.06	Issue Type +	Ma	Location *	LS
Category	Earthen Levee			GPS Latitude/Longitude	
				Start	End
Item	Vegetation			37.979308 °	37.991539 °
				-121.244950 °	-121.296010 °
DWR ID	DWR_NA0017_16_s _ 2016_290				
Comment Code					
V1 : Control annual grass and weeds on the levee slopes and easements.					
Inspector Comment

View of the vegetation on the landside of the levee.

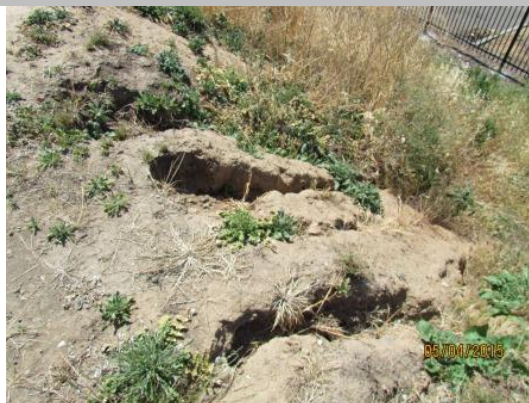
Photo 1 of 2 : SP_2016_NA0017_160_150_20160219_00112.jpg

LM Start	16.43	Rating **	M	Issue No.	150
LM End	16.43	Issue Type +	Ma	Location *	LS
Category	Earthen Levee			GPS Latitude/Longitude	
				Start	End
Item	Erosion / Bank Caving			37.982318 °	37.982318 °
				-121.252095 °	-121.252095 °
DWR ID	DWR_NA0017_16_s _ 2013_150				
Comment Code					
E2 : Schedule repair of erosion site prior to the next inspection.					
Inspector Comment					
Runoff

Updated picture of the erosion on the landside shoulder of the levee looking upstream during spring 2015 inspection.

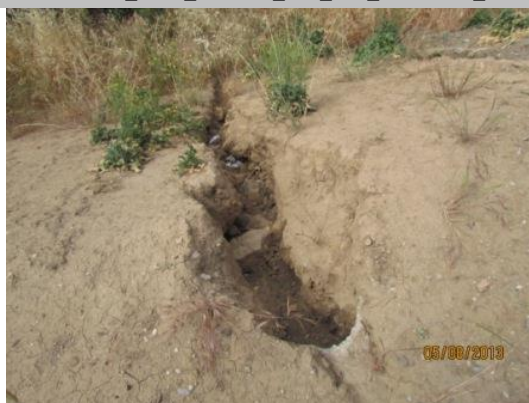
Photo 2 of 2 : SP_2016_NA0017_160_150_20160219_00113.jpg

Erosion was found on the landside of the levee looking downstream.

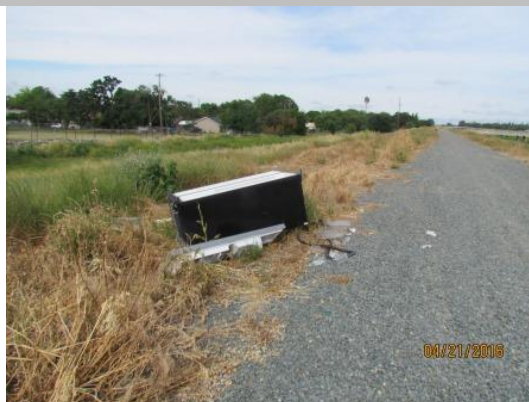
Photo 1 of 1 : SP_2016_NA0017_160_291_20160427_00379.jpg

LM Start	16.70	Rating **	M	Issue No.	291
LM End	16.70	Issue Type +	Ma	Location *	LS
Category	Earthen Levee			GPS Latitude/Longitude	
				Start	End
Item	Encroachments			37.984206 °	37.984206 °
				-121.256440 °	-121.256440 °
DWR ID	DWR_NA0017_16_s _ 2016_291				
Comment Code					
DE : Debris					
Inspector Comment

View of debris on the landside shoulder of the levee.

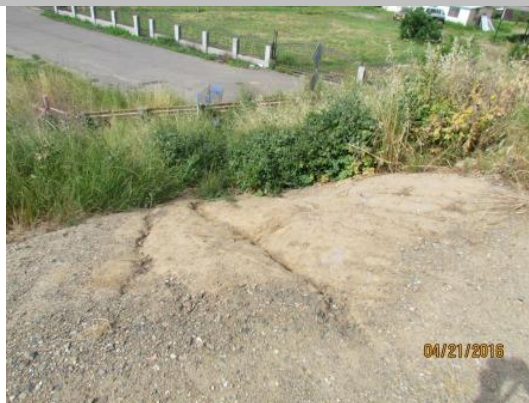
Photo 1 of 1 : SP_2016_NA0017_160_293_20160427_00380.jpg

LM Start	17.14	Rating **	M	Issue No.	293	
LM End	17.14	Issue Type +	Ma	Location *	LS	
Category	Earthen Levee			GPS Latitude/Longitude		
				Start		End
Item	Erosion / Bank Caving			37.987210 °		37.987210 °
				-121.263501 °		-121.263501 °
DWR ID	DWR_NA0017_16_s _ 2016_293					
Comment Code						
E2 : Schedule repair of erosion site prior to the next inspection.						
Inspector Comment						
Runoff

View of an erosion on the landside slope of the levee.

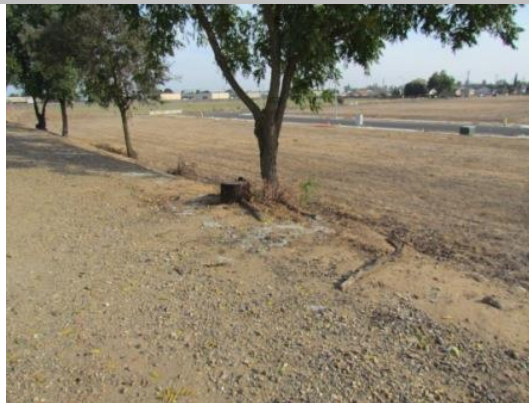
Photo 1 of 1 : SP_2016_NA0017_160_65_20160219_00058.jpg

LM Start	19.04	Rating **	N	Issue No.	65
LM End	19.04	Issue Type +	Ma	Location *	LS
Category	Earthen Levee			GPS Latitude/Longitude	
				Start	End
Item	Trim / Thin Trees			37.991617 °	37.991617 °
				-121.295628 °	-121.295628 °
DWR ID	DWR_NA0017_16_s _ 2012_65				
Comment Code					
T5 : Tree stumps.					
Inspector Comment

A tree stump was found on the landside of the levee looking upstream.

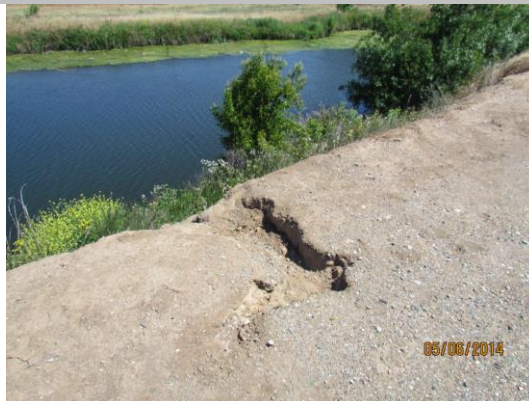
Photo 1 of 2 : SP_2016_NA0017_160_197_20160219_00130.jpg

LM Start	20.97	Rating **	M	Issue No.	197
LM End	20.97	Issue Type +	Ma	Location *	WS
Category	Earthen Levee			GPS Latitude/Longitude	
				Start	End
Item	Erosion / Bank Caving			37.980569 °	37.980569 °
				-121.322985 °	-121.322985 °
DWR ID	DWR_NA0017_16_s _ 2013_197				
Comment Code					
E2 : Schedule repair of erosion site prior to the next inspection.					
Inspector Comment

Updated picture of the erosion on the waterside of the levee looking upstream during spring 2014 inspection.

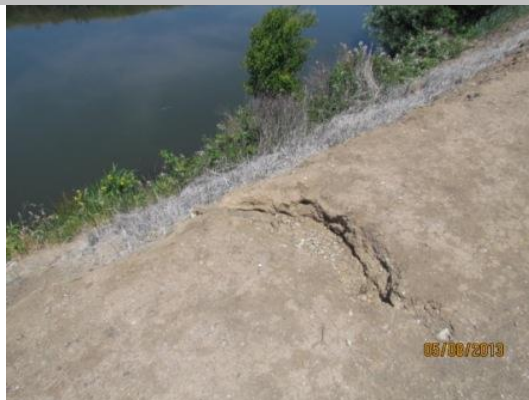
Photo 2 of 2 : SP_2016_NA0017_160_197_20160219_00131.jpg

Erosion was found on the waterside slope of the levee looking upstream.

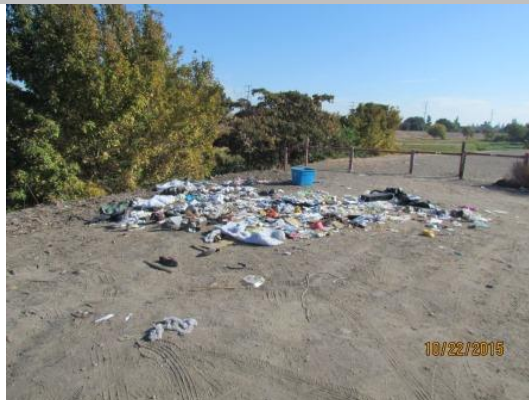
Photo 1 of 1 : SP_2016_NA0017_160_279_20160219_00156.jpg

LM Start	21.07	Rating **	M	Issue No.	279
LM End	21.07	Issue Type +	Ma	Location *	WS
Category	Earthen Levee			GPS Latitude/Longitude	
				Start	End
Item	Encroachments			37.980866 °	37.980866 °
				-121.324682 °	-121.324682 °
DWR ID	DWR_NA0017_16_s _ 2015_279				
Comment Code					
DE : Debris					
Inspector Comment

Debris was found on the waterside shoulder of the levee.

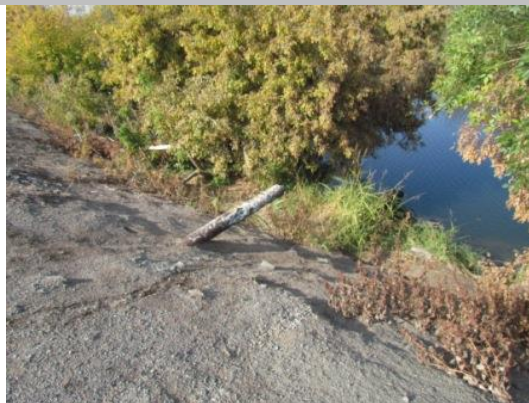
Photo 1 of 1 : SP_2016_NA0017_160_761_20160219_00157.jpg

LM Start	21.54	Rating **	M	Issue No.	761
LM End	21.54	Issue Type +	Ma	Location *	WS
Category	Earthen Levee			GPS Latitude/Longitude	
				Start	End
Item	Encroachments			37.979778 °	37.979778 °
				-121.332810 °	-121.332810 °
DWR ID	DWR_NA0017_16_s_2012_761				
Comment Code					
PI : Pipe					
Inspector Comment

An abandoned pipe was found on the waterside of the levee looking downstream.

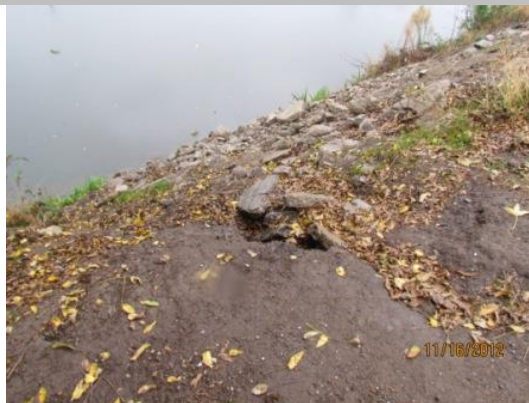
Photo 1 of 1 : SP_2016_NA0017_160_68_20160219_00061.jpg

LM Start	21.68	Rating **	M	Issue No.	68
LM End	21.68	Issue Type +	Ma	Location *	WS
Category	Earthen Levee			GPS Latitude/Longitude	
				Start	End
Item	Erosion / Bank Caving			37.979674 °	37.979674 °
				-121.335228 °	-121.335228 °
DWR ID	DWR_NA0017_16_f_2012_68				
Comment Code					
E2 : Schedule repair of erosion site prior to the next inspection.					
Inspector Comment

Erosion was found on the waterside slope of the levee looking upstream.

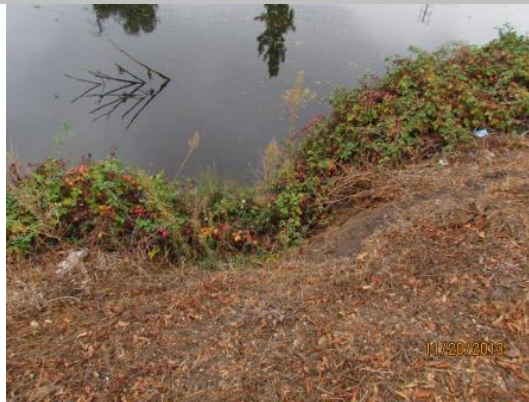
Photo 1 of 1 : SP_2016_NA0017_160_62_20160219_00053.jpg

LM Start	21.94	Rating **	M	Issue No.	62
LM End	21.94	Issue Type +	Ma	Location *	WS
Category	Earthen Levee			GPS Latitude/Longitude	
				Start	End
Item	Erosion / Bank Caving			37.979251 °	37.979251 °
				-121.340012 °	-121.340012 °
DWR ID	DWR_NA0017_16_f_2013_62				
Comment Code					
E2 : Schedule repair of erosion site prior to the next inspection.					
Inspector Comment

Erosion was found on the waterside slope of the levee looking upstream.

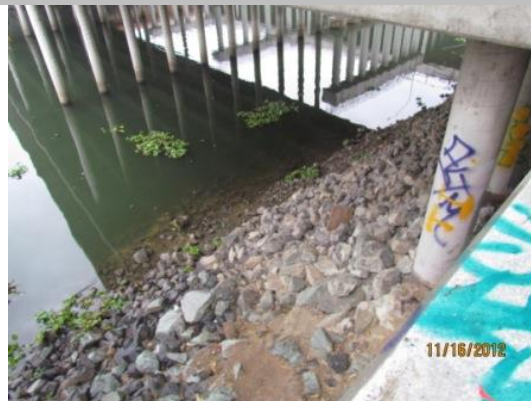
Photo 3 of 5 : SP_2016_NA0017_160_48_20160219_00040.jpg

LM Start	22.04	Rating **	A/W	Issue No.	48 (cont)	
LM End	22.04	Issue Type +	Ma	Location *	WS	
Category	Earthen Levee			GPS Latitude/Longitude		
				Start		End
Item	Erosion / Bank Caving			37.978697 °		37.978697 °
				-121.341581 °		-121.341581 °
DWR ID	DWR_NA0017_16_s_2012_48					
Comment Code						
E2 : Schedule repair of erosion site prior to the next inspection.						
Inspector Comment						
Caltrans repaired the issue. (Permit # 18532) Another repair might be needed if it deteriorates.

Updated view of the erosion site repaired by Caltrans on the waterside slope of the levee looking upstream.

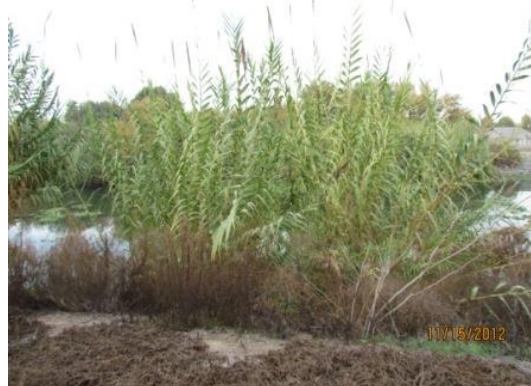
Photo 1 of 1 : SP_2016_NA0017_160_45_20160219_00034.jpg

LM Start	22.55	Rating **	U	Issue No.	45
LM End	22.55	Issue Type +	Ma	Location *	WS
Category	Earthen Levee			GPS Latitude/Longitude	
				Start	End
Item	Vegetation			37.973386 °	37.973386 °
				-121.348241 °	-121.348241 °
DWR ID	DWR_NA0017_16_f_2012_45				
Comment Code					
V2 : Remove the wild growth other than native grasses from the levee slopes.					
Inspector Comment					
Arrundo on the waterside of the levee.

Arrundo was found on the waterside slope of the levee looking upstream.

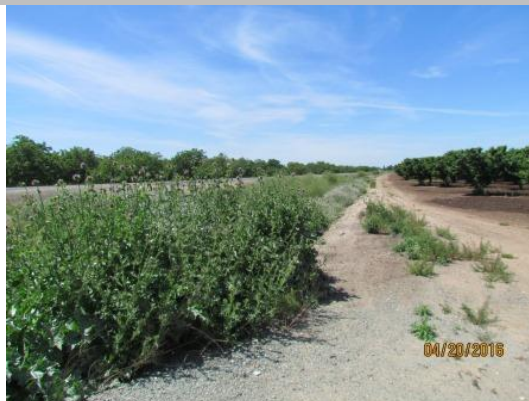
Photo 1 of 1 : SP_2016_NA0017_161_7_20160427_00017.jpg

LM Start	0.13	Rating **	M	Issue No.	7
LM End	0.31	Issue Type +	Ma	Location *	WS
Category	Earthen Levee			GPS Latitude/Longitude	
				Start	End
Item	Vegetation			37.959971 °	37.959505 °
				-121.161177 °	-121.157914 °
DWR ID	DWR_NA0017_17_f_2015_7				
Comment Code					
V1 : Control annual grass and weeds on the levee slopes and easements.					
Inspector Comment

View of the vegetation on the waterside of the levee looking downstream.

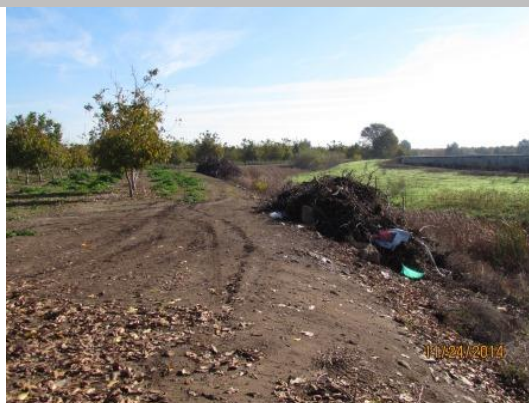
Photo 1 of 2 : SP_2016_NA0017_161_5_20160219_00004.jpg

LM Start	0.60	Rating **	M	Issue No.	5
LM End	0.60	Issue Type +	Ma	Location *	WS
Category	Earthen Levee			GPS Latitude/Longitude	
				Start	End
Item	Encroachments			37.958966 °	37.958966 °
				-121.152641 °	-121.152641 °
DWR ID	DWR_NA0017_17_s_2012_5				
Comment Code					
PR : Prunings					
Inspector Comment

Updated picture of the prunings on the waterside of the levee looking upstream during fall 2014 inspection.

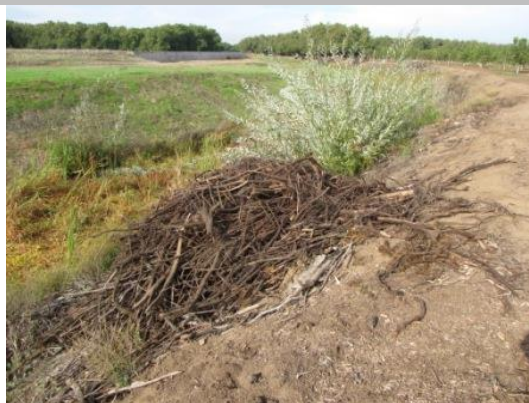
Photo 1 of 1 : SP_2016_NA0017_161_3_20160219_00002.jpg

LM Start	0.68	Rating **	M	Issue No.	3
LM End	0.68	Issue Type +	Ma	Location *	WS
Category	Earthen Levee			GPS Latitude/Longitude	
				Start	End
Item	Encroachments			37.958590 °	37.958590 °
				-121.151408 °	-121.151408 °
DWR ID	DWR_NA0017_17_s_2012_3				
Comment Code					
PR : Prunings					
Inspector Comment

View of a prunings pile along the waterward bank looking downstream.

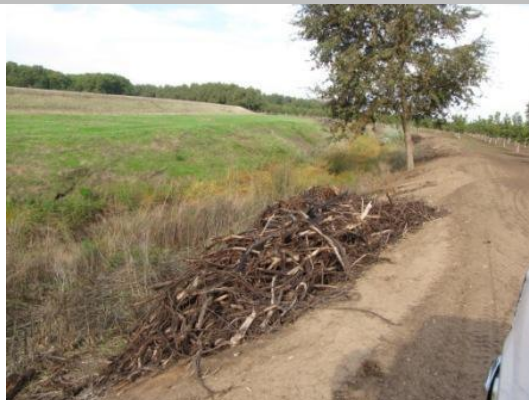
Photo 1 of 1 : SP_2016_NA0017_161_2_20160219_00001.jpg

LM Start	0.78	Rating **	M	Issue No.	2
LM End	0.78	Issue Type +	Ma	Location *	WS
Category	Earthen Levee			GPS Latitude/Longitude	
				Start	End
Item	Encroachments			37.957934 °	37.957934 °
				-121.149911 °	-121.149911 °
DWR ID	DWR_NA0017_17_s_2012_2				
Comment Code					
PR : Prunings					
Inspector Comment

View of a prunings pile along the waterward bank looking downstream.

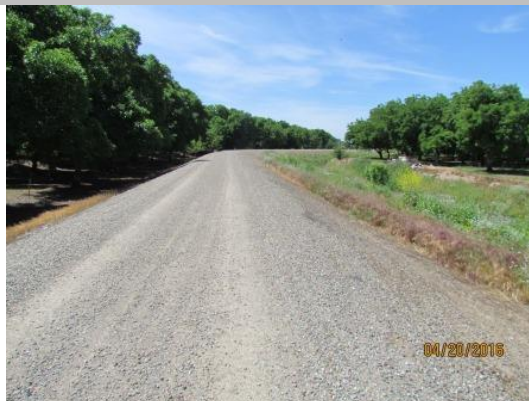
Photo 1 of 1 : SP_2016_NA0017_162_3_20160427_00005.jpg

LM Start	0.33	Rating **	A	Issue No.	3
LM End	0.33	Issue Type +	Ma	Location *	WS
Category	Earthen Levee			GPS Latitude/Longitude	
				Start	End
Item	Vegetation			37.958687 °	37.958687 °
				-121.153970 °	-121.153970 °
DWR ID	DWR_NA0017_18_s_2016_3				
Comment Code					
V1 : Control annual grass and weeds on the levee slopes and easements.					
Inspector Comment

View of the vegetation on the waterside of the levee looking downstream.
